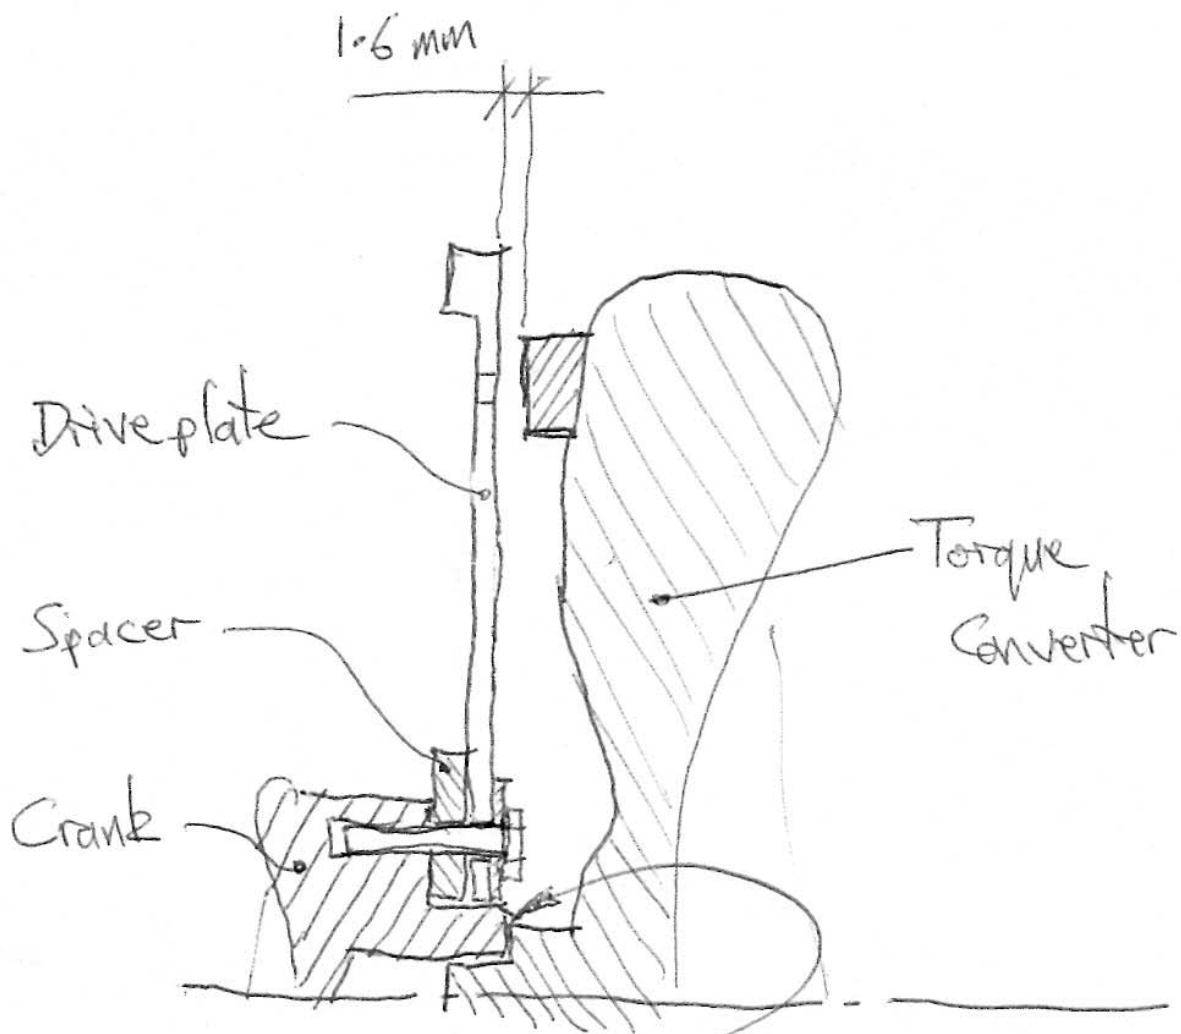
Shoulder on spigot hard against crank. Approx 2mm gap at boss.

Witness marks on boss and drive plate show it was originally bolted tight.

Is a  $\pm 2\text{mm}$  ok acceptable or should washers be used between boss and drive plate?
